Ocean Drive (CR 621) Upgrades & Bridge Improvements  
Local Concept Development Study  
Township of Lower, Cape May County, New Jersey

# Final Concept Development Report

February 2021

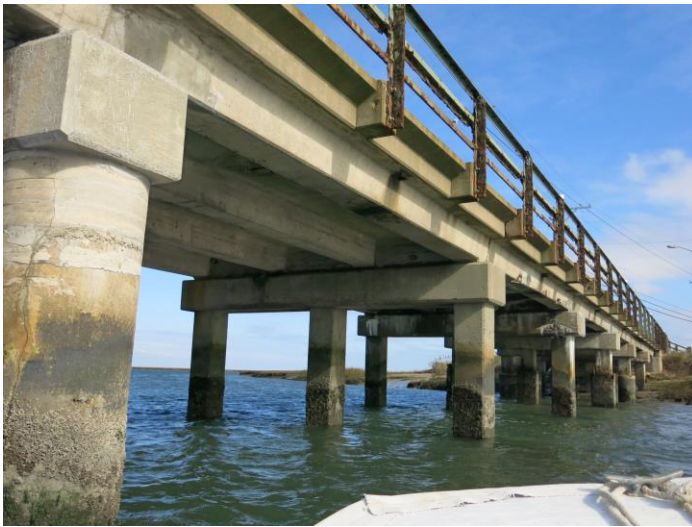
**Figure 4: Mill Creek Bridge**

This bridge (**Figure 4**) was constructed in 1939 to connect Cape May to the Wildwoods and consists of twelve 25'-0" spans with a total length of 300'-0". The bridge provides two 10'-0" wide lanes and 1'-6" safety walks on both sides and is on a tangent section of roadway. The superstructure is composed of four reinforced concrete T-beams with a monolithic 7½" thick reinforced concrete deck.

The beams are spaced at approximately 6'-0" on center support with a total deck width of 23'-0". The substructure consists of reinforced concrete pile bents and stub abutments on timber piles. The substructure is comprised of two bin-type abutments on timber piles and piers consisting of reinforced concrete pier caps with three precast concrete piles at each pile bent pier. Rip Rap and bagged concrete slope protection were visible at the abutments, apparently placed to counter prior scour and erosion.

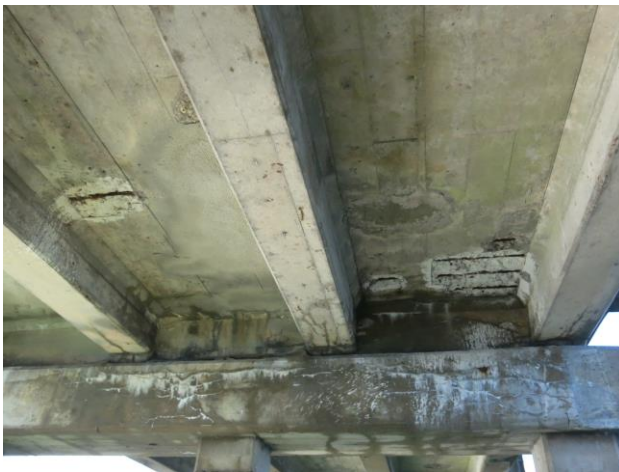
**Figure 5: Mill Creek Bridge - Underside of Deck**

The superstructure (including deck slab and beams) is in fair condition. The deck is in fair condition due to the light to moderate scaling throughout all spans with several spans also exhibiting shallow spalling on both the top and underside (**Figure 5**), and cracking with asphalt patches on the top of the deck. There is exposed reinforcement in all spans at the underside top flanges of the T-beams. The T-beams exhibit cracking and spalling along the web in several spans. The bottoms of the beams are spalled at several locations, including the previously repaired sections. The reinforcement is exposed and rusted throughout.

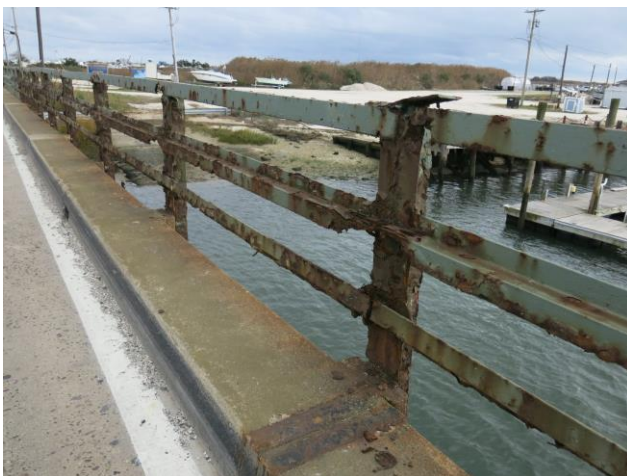
**Figure 6: Mill Creek Bridge Railing**

The bridge railing is severely deteriorated and is also substandard since it does not meet strength or geometric requirements. The majority of the rails are rusted through (see **Figure 6**). The railing exhibits several locations of previous vehicular impact. NJDOT Item 36 for Bridge railings, approach railings, transitions and end terminals are all deficient, as per the 17th Cycle Bridge Re-evaluation Survey Report.

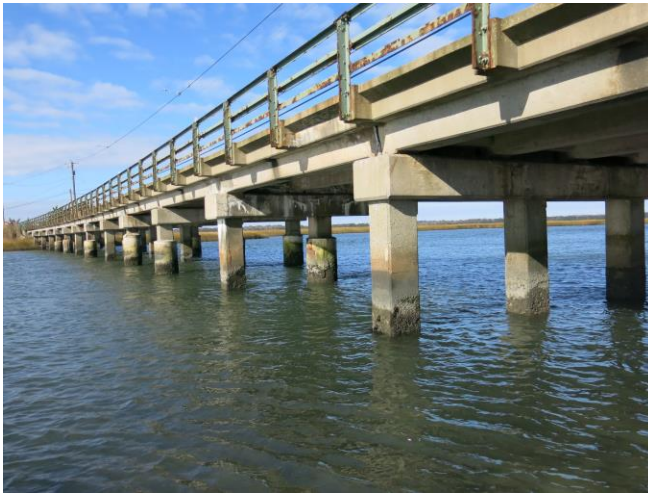
**Figure 7: Upper Thorofare Bridge**

The superstructure (deck slab and beams) is in fair condition. The concrete T-beams typically have wide cracks and efflorescence at the bearing locations (**Figure 7**). The deck has both armored and non-armored joints over the piers. The joint material in most of these joints is deteriorated.

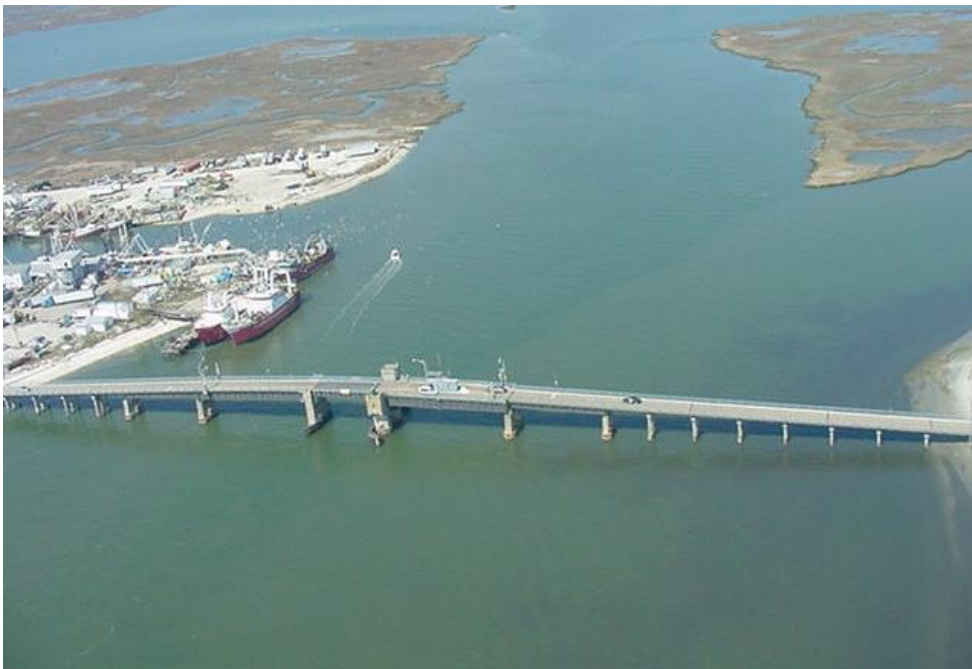
**Figure 8: Middle Thorofare Bridge**

There are seventeen 35'-0" long spans that consist of three continuous steel stringers with pin and hanger assemblies supporting an 8" reinforced concrete deck slab. The other four approach spans are two girder, floorbeam/sub-stringer structures with an 8" reinforced concrete deck slab that is supported on the two girders and central sub-stringer. This structure is on a tangent section of roadway. The overall condition of the structure is critical due to its low ratings. The bridge is deemed functionally obsolete due to its narrow width, and structurally deficient due to its inability to carry loads greater than 15 tons. These findings are based upon the 14th Cycle Bridge Re-evaluation Survey Report, dated October 2015 and a cursory assessment performed on November 15, 2017. Additionally, the major fishing industry in the vicinity of the bridge also has a significant demand on the bridge openings.

The bascule leaf is comprised of two steel girders, to which trunnion assemblies are mounted. The bascule girders are approximately at the same elevation and have an approximate center-to-center spacing of 22'-3". A trunnion shaft is attached to each girder and it's simply supported by bronzed bushed sleeve bearings at the ends (total of four bearings, two per girder). The two simply supported trunnions support the weight of the bascule leaf. At the rear of the trunnions, the girders support the counterweight located below the east flanking approach span. Each approach to the bascule span is equipped with traffic signals and warning gates. The west warning gates; one at each corner spans the west approach span when lowered. The northeast warning

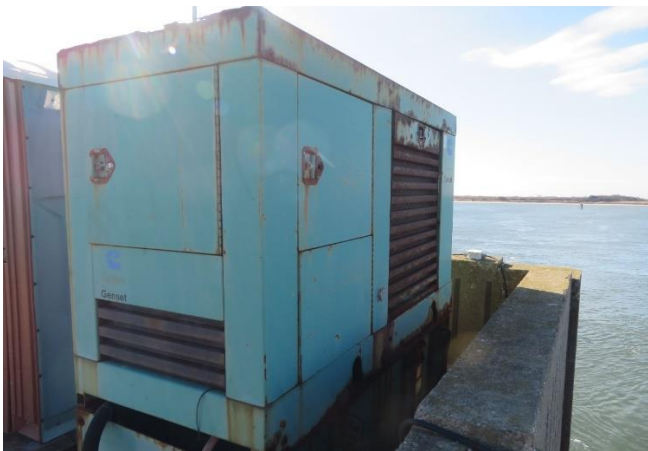
**Figure 9: Generator**

The bridge mechanical systems consist of span drive machinery, span support machinery (trunnion bearing assemblies, live load bearings, span lock machinery) and overtravel bumper blocks. In the event of loss of normal electrical power, the bridge is equipped with a standby 60 kW diesel powered generator (**Figure 9**) to provide emergency electrical power. The existing auxiliary drive system is original to the bridge and comprises of a gasoline engine, a coupling, reversing unit and clutch assembly located in the machinery room. The auxiliary drive system is not in use and showed signs of age. The components appeared to not have been serviced in a long time and appeared abandoned in place.

A loss of utility power was simulated by disconnecting the primary switch outside the transformer room. Once power was disconnected, the generator on roadway level started immediately, confirming that the ATS is functional. The control desk is functional, however it is antiquated, and obsolete, and spare parts are very hard to find, if at all, and found to be in poor condition. The analog span position meter needs to be recalibrated – at the fully seated position it still indicated that the span was open 15 degrees. Several indication lights were non-functional. There is no emergency stop button on the control desk. Labels for the buttons and indicators were handwritten.

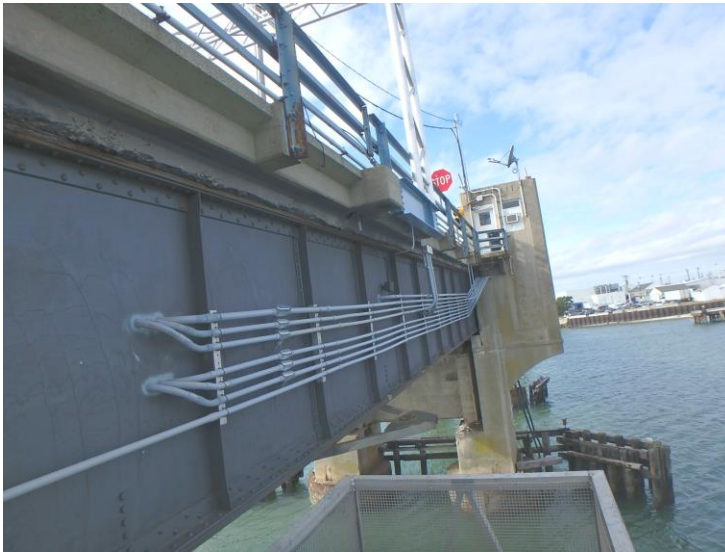
**Figure 10: New Utilities and EZ-Pass**

Since the previous inspection, new utility lines running along the structure have been installed. The infrastructure for EZ-Pass has been installed at the toll booth location with new overhead utilities as shown in **Figure 10**.

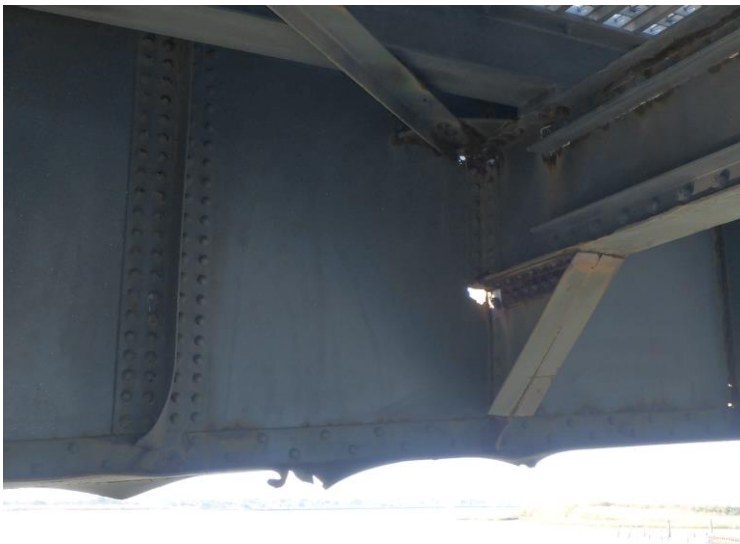
**Figure 11: Bascule span damage**

The superstructure is in poor condition due to holes, vessel collision damages on bascule spans' girders (**Figure 11**) and arrested section loss on steel girders and all steel elements throughout the structure. Bearings exhibit severe-pack rust. Severe collision damage/torn flange angle was noted, and the County was informed of this condition for further coordination with the NBIS inspection team.

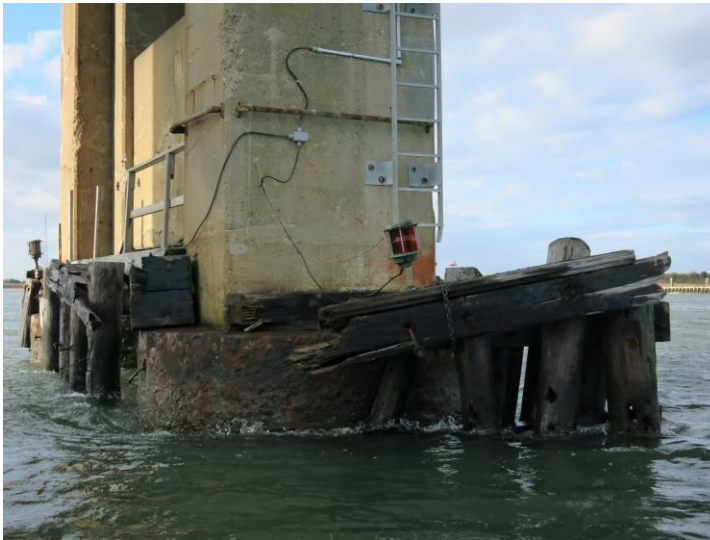
**Figure 12: Timber Fender**

The precast concrete piles were repaired at several locations with concrete jackets. The sleeves are heavily deteriorated at several locations with the reinforcing cage exposed. Pier S7 consists of three concrete piles. The east pile has heavy collision damage and has been supplemented with two steel H-piles for additional support.

The main piers and timber fender system are generally in poor condition (**Figure 12**). The fender timber piles have up to 90% section loss. Many piles including dolphins were swaying from small wake. The timber fender is severely deteriorated.

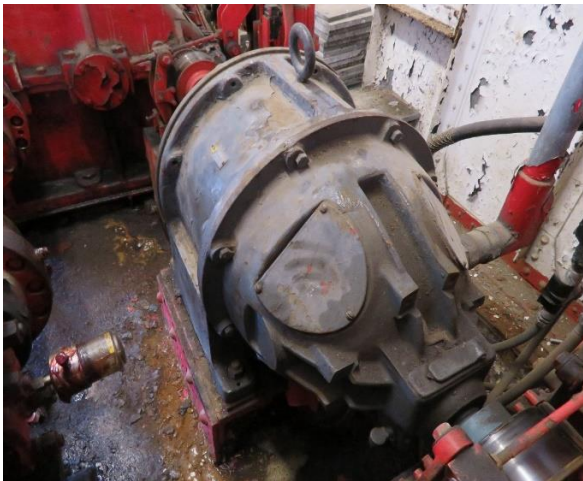
**Figure 13: Motor**

The motor (**Figure 13**) is original and showed signs of age but operated satisfactorily. The housing exterior exhibited paint failure and corrosion.

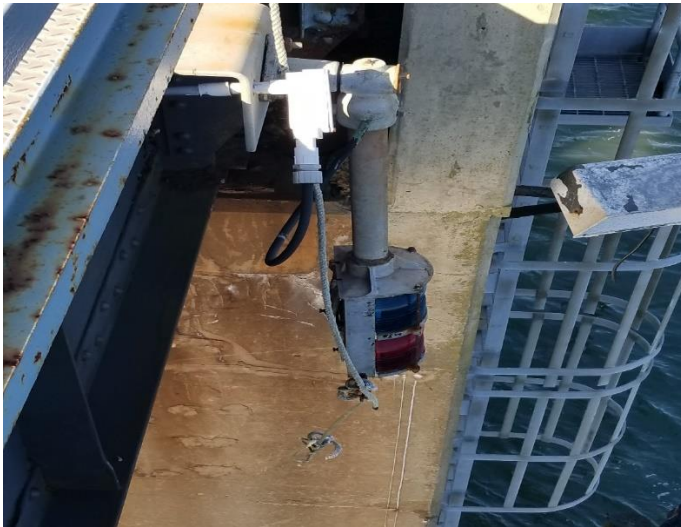
**Figure 15: Green-Over-Red Channel Navigation Light**

The channel navigation light consisted of one green-over-red channel navigation light on the north side of the span that was found to be in fair condition (**Figure 15**). The marine horn was functional but showed signs of moderate corrosion. The CCTV cameras were in fair condition; however, the bridge operator does not have access to the camera feed.

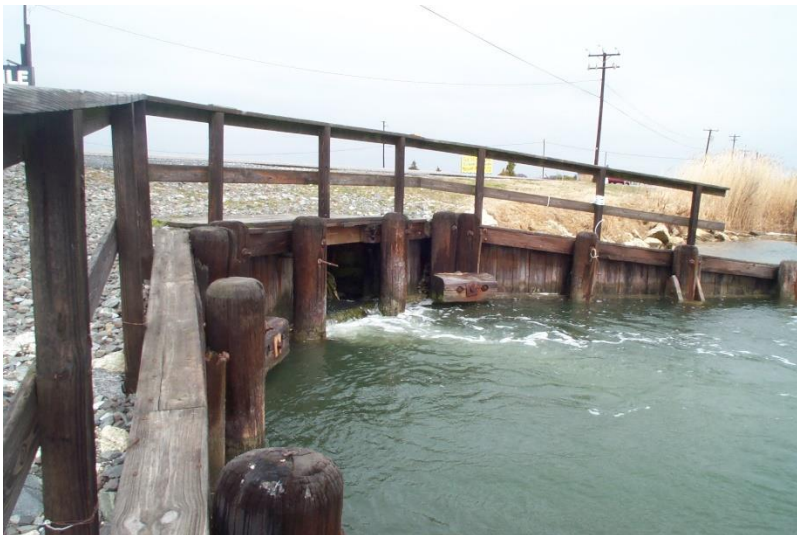
**Figure 16: Old Lower Thorofare Culvert**

This culvert (**Figure 16**) is considered a minor bridge and is not inspected on a regular basis since it is presently a 5-foot diameter pipe; however, this culvert is being inspected in 2021 as part of the NJDOT's minor bridge inspection program. The flow of water through this pipe is typically very swift during tide changes. The pipe appears to be undersized for the flow.

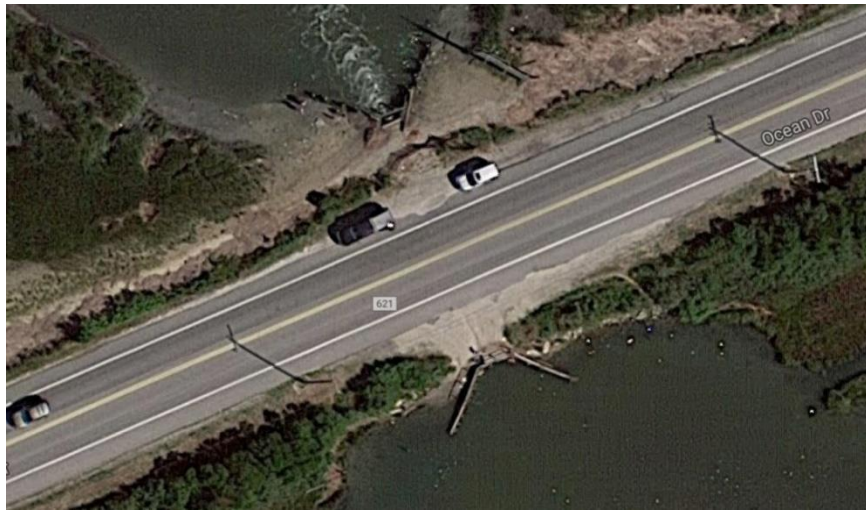
**Figure 19: Existing Culvert**

The existing pipe culvert just west of Fish Dock Road is a gathering place for recreational fishing and crabbing. This culvert is the only waterway that permits water to flow from the east side of Ocean Drive to the west side during tidal changes. The pipe is undersized and typically has water flowing through it at a high velocity as shown in **Figure 19**.

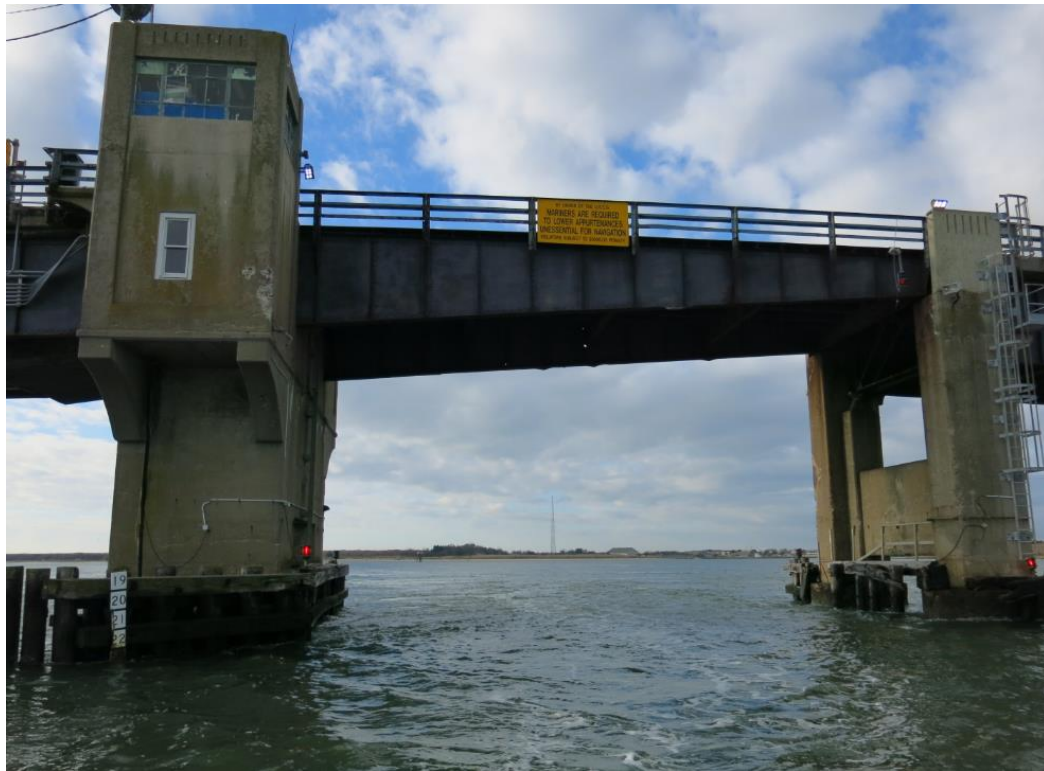
**Figure 22: Existing Bascule Span**

The Replace In-Kind Alternative would retain the historic character of the existing Middle Thorofare Bridge by constructing a replacement bridge "in-kind", keeping the character, type, and style of the existing bridge intact while increasing its load carrying capacity to current standards, providing a scour resistant subsurface and improving operating and safety conditions where possible. In order to maintain the appearance of the existing bridge to the largest extent possible, it is estimated that the replacement bridge in this alternative would be reconstructed with the same span lengths while the bridge width would be increased to accommodate two 12-foot travel lanes and 8-foot shoulders, consistent with the approach roadways. The main span would not be capable of spanning the 80-foot fender to fender necessary based on the Navigational Report and still match the existing single leaf bascule span shown in **Figure 22**.

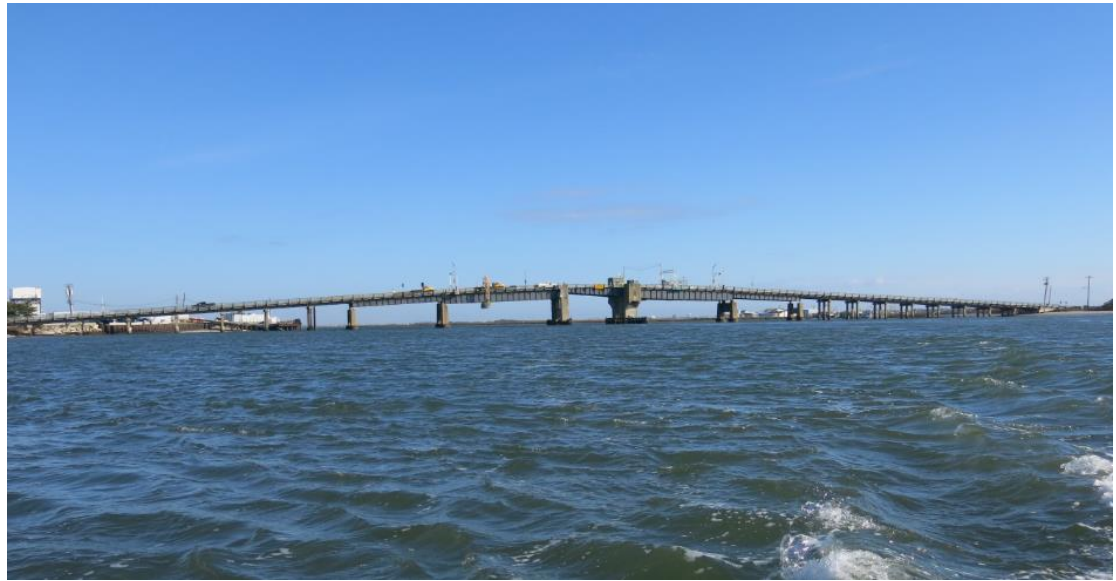
**Figure 23: Existing Middle Thorofare**

Leaving the bridges unaltered, particularly the Middle Thorofare Bridge (**Figure 223**), will allow their deterioration to continue and will assuredly result in future repairs or replacements. The condition of the Middle Thorofare Bridge is such that a major storm could cause enough damage to require an immediate closure of the bridge and substantial disruption to the surrounding community and businesses. Routine maintenance and operation of the roadway would continue.

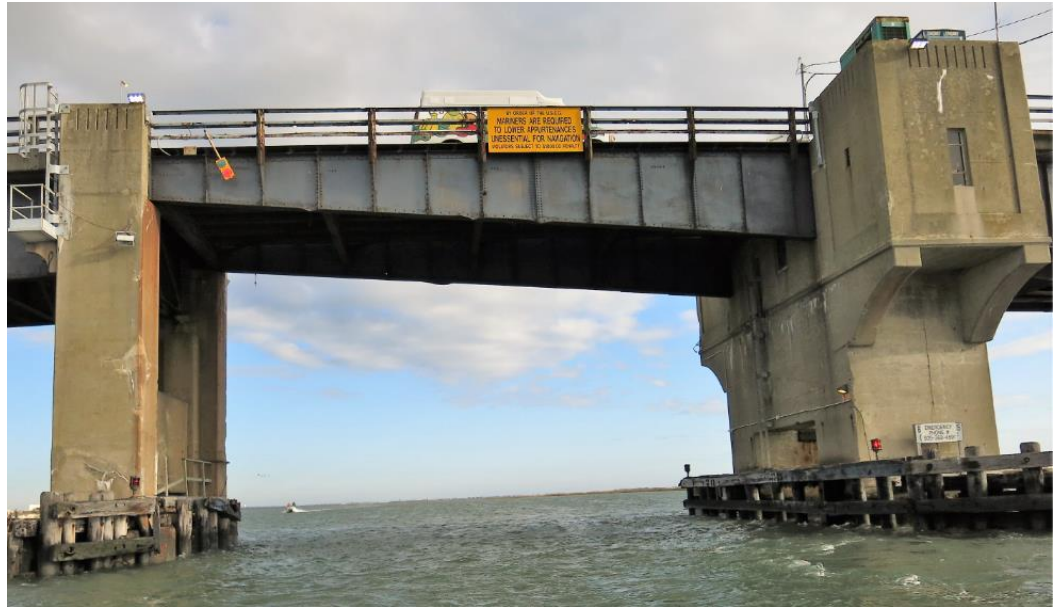
**Figure 24: Existing Bascule Span**

The existing structural steel for the Middle Thorofare Bridge (even before it was severely corroded) was not capable of supporting a 36-ton vehicle, and it is not possible to increase the strength on the majority of the structure without replacing or supplementing that steel. Therefore, the main longitudinal beams, which run the length of the structure, must be replaced or supplemented with additional beams. The remainder of the bridge, which is comprised of the girder spans approaching the bascule span and the bascule span itself (**Figure 24**), is supported on only two longitudinal girders.

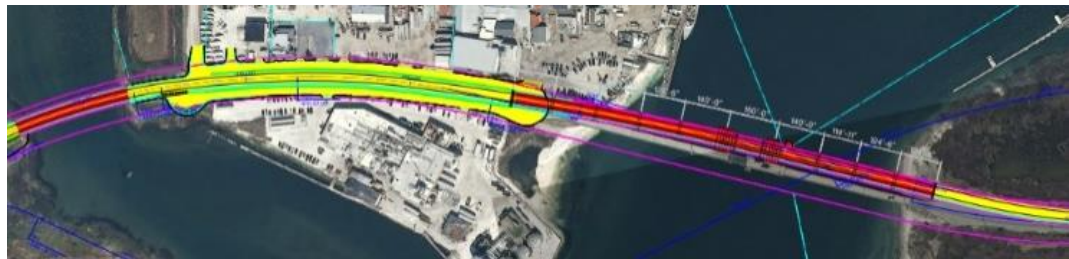
**Figure 25: Alternative 6 Alignment**

For Alternatives 6A and 6B, the horizontal alignment of all three bridges will be shifted to the north. The Middle Thorofare Bridge will be replaced with a double leaf movable bridge with a 45' vertical clearance along the navigation channel. The vertical clearance determination can be found in the Navigation Impact Report. The main difference between alternatives 6A and 6B are the proposed pier types.

Alternative 6 is an alignment that is parallel to the existing structure to the North shown in **Figure 25**. This alignment facilitates the minimum impact at the abutments and does not impact the force main to the south of the existing structure. The Middle Thorofare Bridge includes a double leaf bascule main span. As per the Navigational Report, the main span will have a 45-foot vertical underclearance and an 80-foot horizontal clearance. In order to meet the vertical clearance and approach grades of 5%, an access road is required to maintain existing access to the local businesses seen in **Figure 26**.

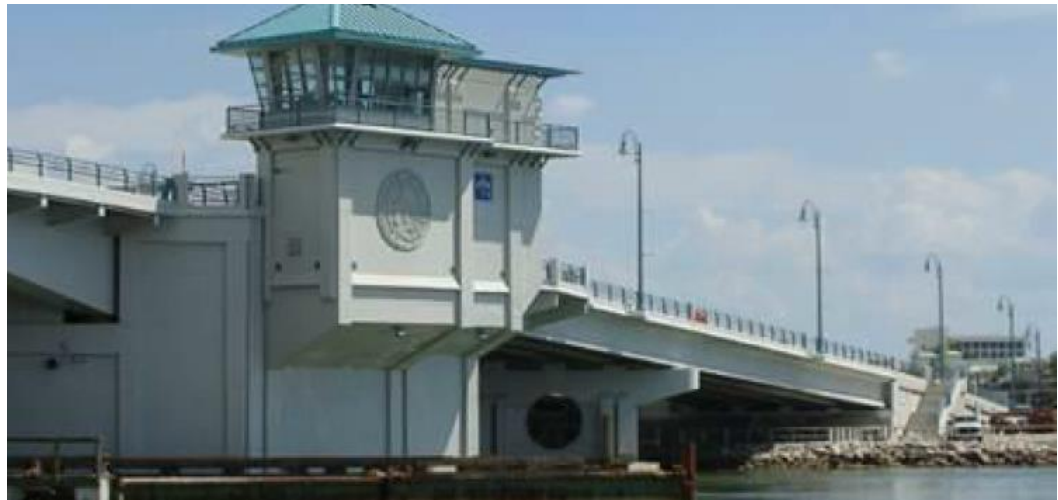
**Figure 29: Sample Operators House**

In order to accommodate a one-person staff to operate both the toll booth and on command bascule span opening, a 15' x 20' operators house (seen in **Figure 29**) will be cantilevered off the north of the east approach main span. A 7' wide toll booth will be provided in the same span at the middle of the alignment.

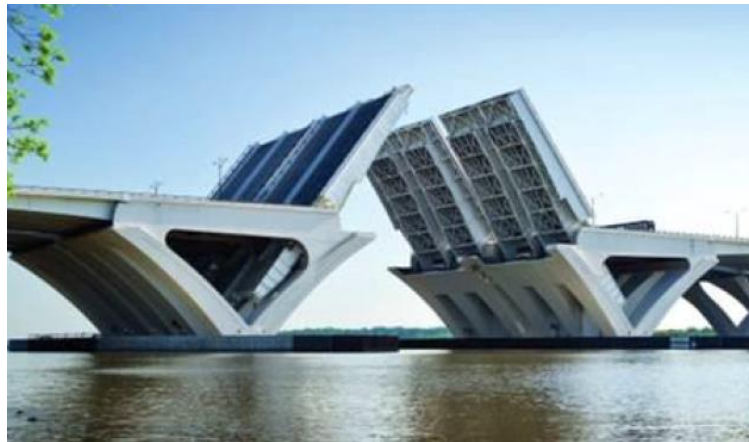
**Figure 32: Example Open Pier Concept**

An example of an open concept pier with the bascule span open can be seen in **Figure 32**.
