Traffic Engineering Consultant Services

EVALUATION OF INTERSECTION IMPROVEMENTS

Salem County, New Jersey

June 2021
SALEM21001

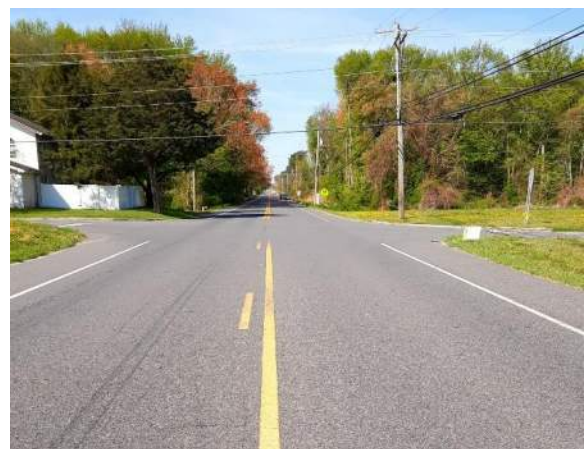
Photo 4: Elmer-Shirley Road (CR 611) looking west from intersection.

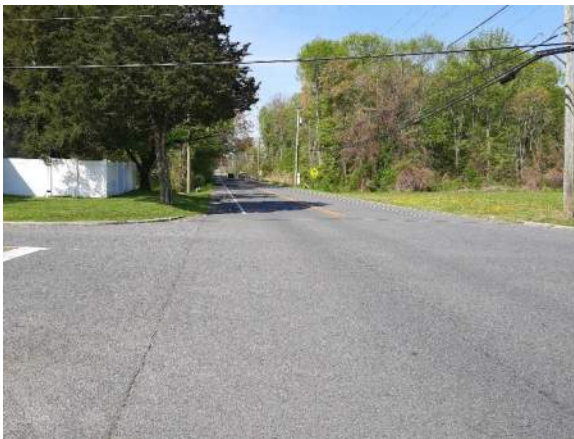
At the intersection of Elmer-Shirley Road (CR 611) and Burlington Road (CR 677), the pavement on both Elmer-Shirley Road and Burlington Road is in good condition. Curbing is present at each corner of the intersection and the curb is in good condition. Elmer-Shirley Road appears to have been resurfaced and the pavement markings are in good condition. Burlington Road has 4 sets of painted rumble strips on each leg approaching the stop line. The pavement markings on Burlington Road, aside from those immediately at the intersection, are functional but do show significant wear. The pavement and pavement marking condition are shown in Photos 5 and 6.

Photo 5: Elmer-Shirley Road (CR 611) looking West from intersection

The pavement markings on Elmer-Shirley Road (CR 611) and the stop lines on Burlington Road (CR 677) are relatively new and in good shape. The pavement markings on Burlington Road (CR 677) are in fair condition and functionable, but it is recommended as part of the intersection improvements that the rumble strips on Burlington Road be refreshed. As part to the recommended conversion from a two-way stop to a 4-way stop, stop lines, and rumble strips are to be added to Elmer-Shirley Road (CR 611).

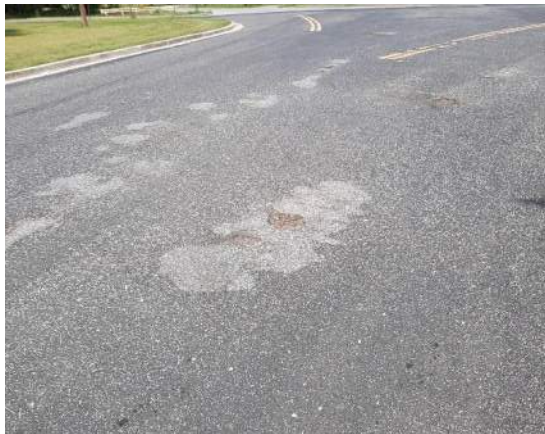
At the intersection of Sinnickson Landing Road (CR 661)/Tilbury Road (CR 661) and South Tilbury Road (CR 627) and Garden Drive is in poor condition with potholes and evidence of previous pothole repair. The pavement located at the remaining legs of the intersection are in fair condition. The pavement markings at the intersection are in fair condition. The pavement and pavement markings are illustrated in Photos 12 and 13.

Photo 12: Roadway and Pavement Markings –
Southern Leg of Intersection

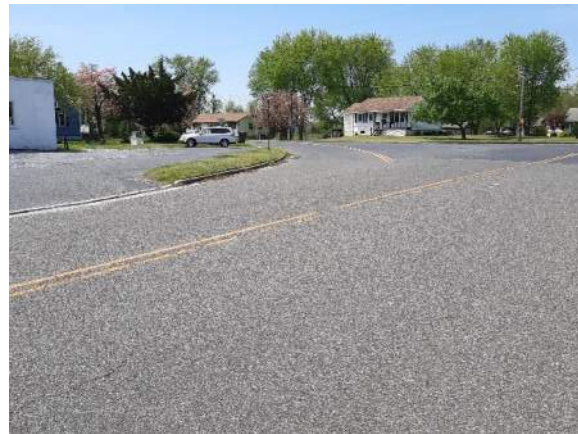
Photo 13: Roadway and Pavement Markings –
East Leg of Intersection

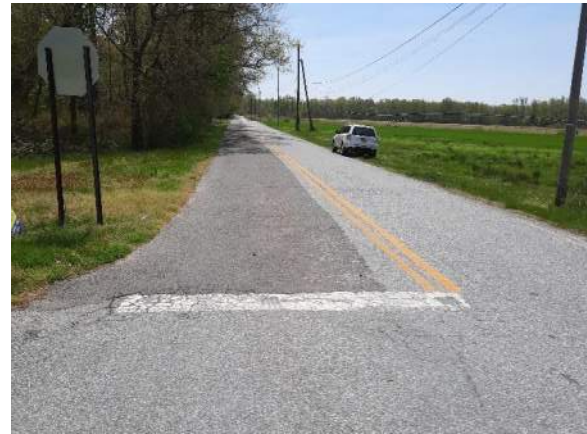
Photo 17: Looking south on Straughns Mill Road (CR 643) from the intersection

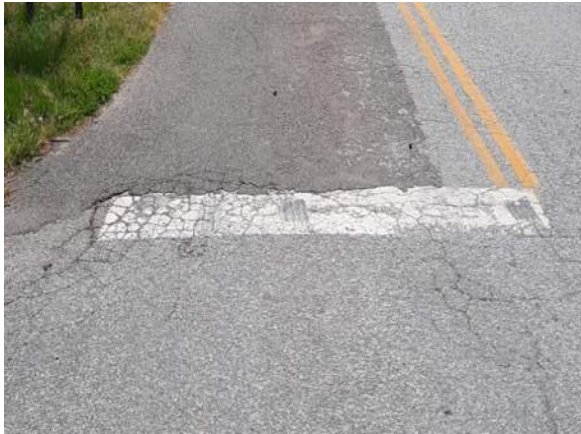
Photo 18: Stop Bar at the northbound approach –cracking and faded pavement markings.

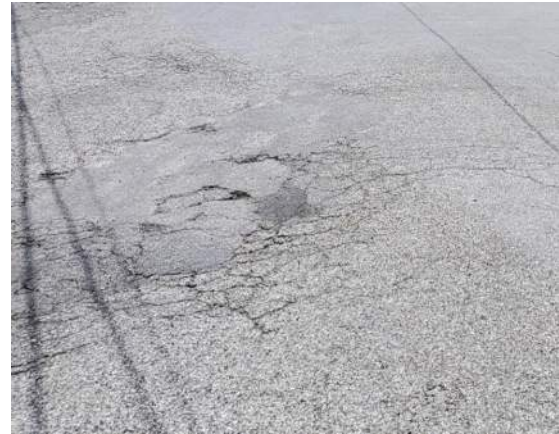
Photo 19 Northwest corner of the intersection – pothole repair and cracking.

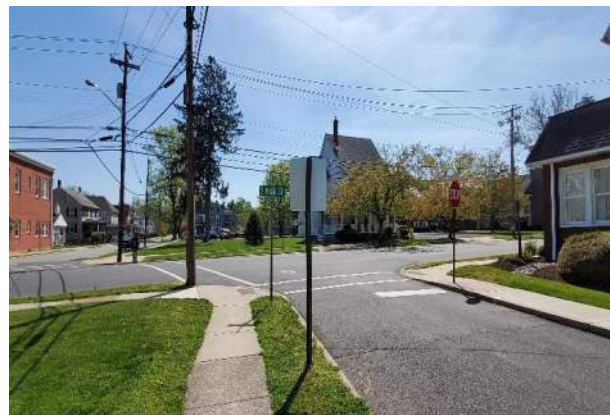
Photo 23: Looking east on Green Street

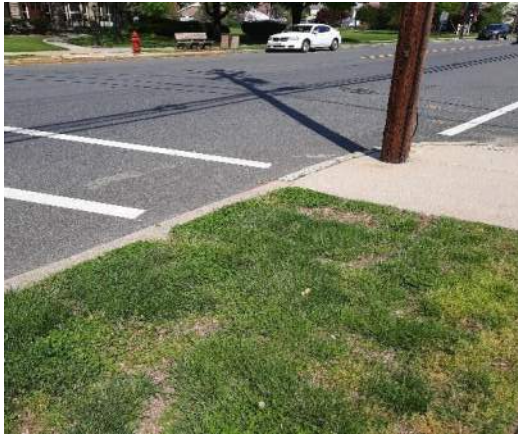
Photo 24: Southeast corner, receiving end of crosswalk at Dickinson Street.

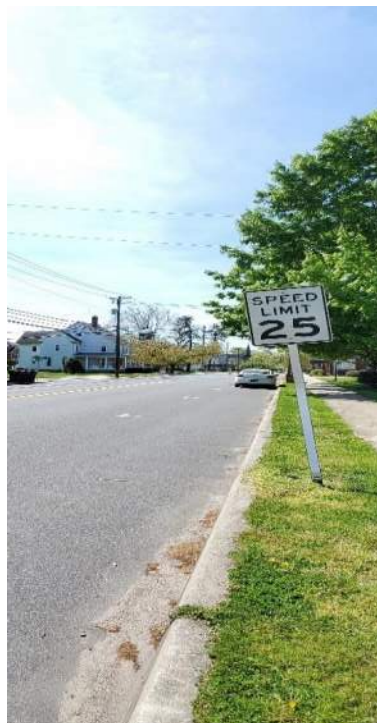
The speed data analysis showed that the 85th percentile speed on South Main Street (CR 672) between Green Street and Church Street is 30 mph, which is comparable with posted speed limit.

Photo 26: Posted Speed Limit on southbound approach, approximately 100 feet north of study intersection

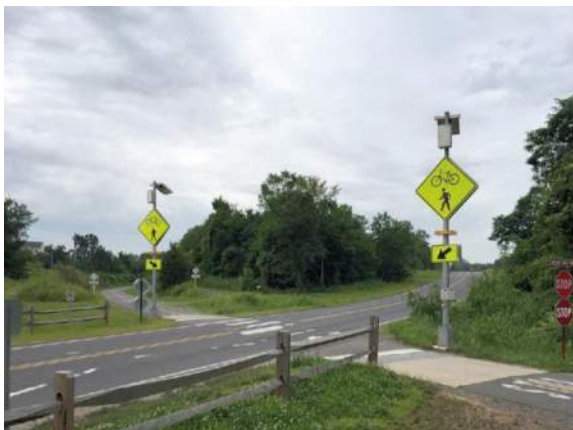
RRFBs can be automated (i.e., video or infrared), and/or can be manually activated via manual-push buttons. It should be noted that RRFBs typically receive power through solar panel units, however, for an installation at South Main Street (CR 672) and Green Street/Dickinson Street it is recommended that can be supplied through traditional means due to close proximity of existing utility lines. See photos 27 and 28 for examples of RRFBs.

Photo 27: Rectangular Rapid Flashing Beacons at a trail crossing

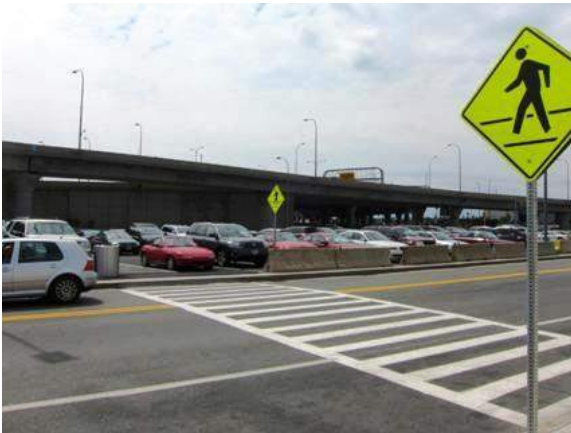
Photo 29: "Ladder" style crosswalk.

It is recommended as part of the intersection improvements that the existing stop lines on Dickinson Street and Green Street be refreshed. It is also recommended that the County consider using a "ladder" style crosswalk to increase visibility, specifically for the crosswalk crossing South Main Street (CR 672). Photo 29 illustrates an example of a "ladder" style crosswalk. In addition, it is recommended that the County should consider the use of "PED XING" pavement markings approaching the crosswalks. Photo 30 illustrates an example of a "Ped XING" pavement markings.

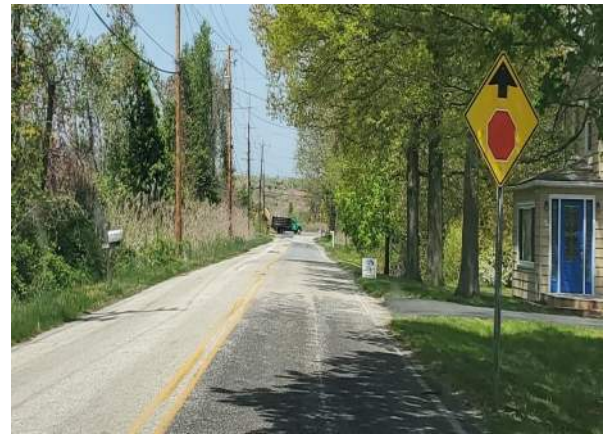
Photo 34: Looking north on North Railroad Avenue (CR 602), approximately 500 feet south of US Route 130

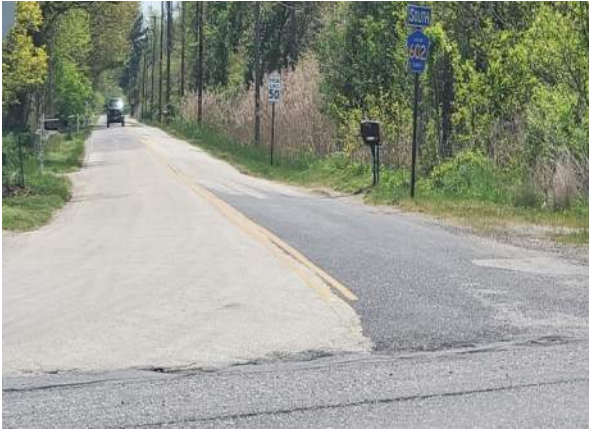
Photo 35: Southbound approach at the intersection of US Route 130 and North Railroad Avenue (CR 602) – fatigue cracking, fair pavement markings

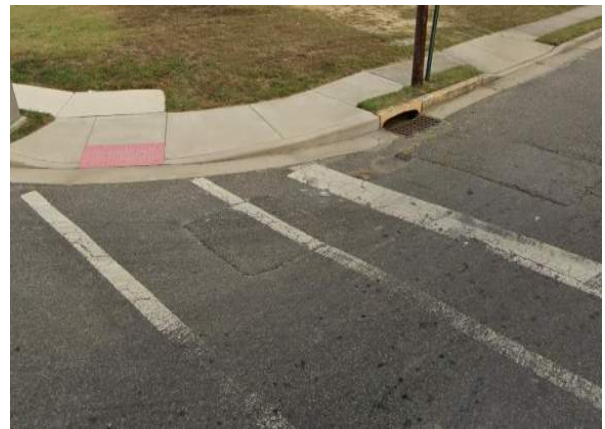
Photo 36: Westbound approach of West Mill Street (CR 642) intersecting North Railroad Avenue (CR 602) - Stop Bar / cracking / poor pavement markings.

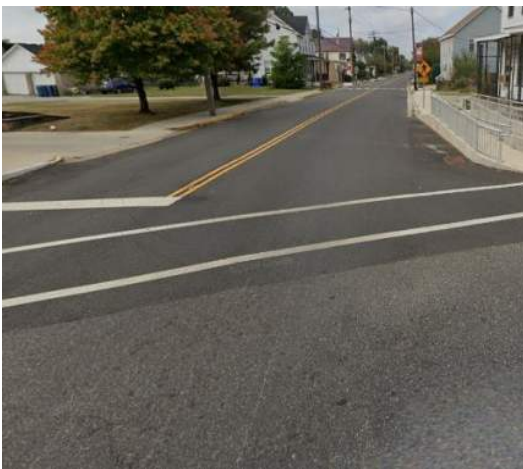
Photo 37: Eastbound approach of West Mill Street (CR 642) of the intersection – pavement and pavement markings in good condition

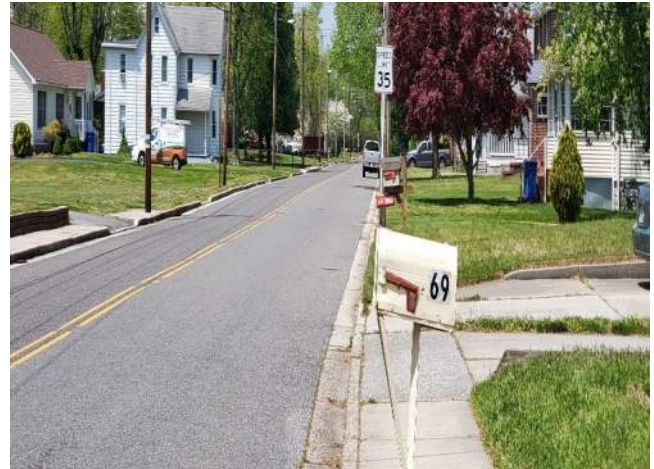
Photo 38: Northbound approach of North Railroad Avenue (CR 602) – pavement in good condition, pavement markings in fair condition

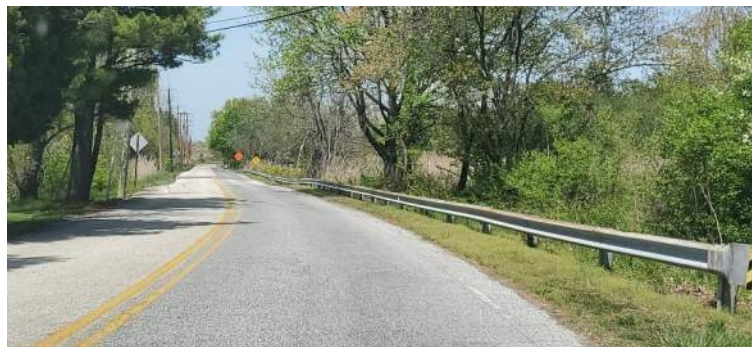
The guiderail (Photo 39) on the northbound side of the North Railroad Avenue (CR 602), north of Lerro Road is not standard. The approach end of the guiderail is not crashworthy, and the current guiderail is not compatible with the latest MASH (Manual for Assessing Safety Hardware) requirements.

Photo 39: Guiderail on the northbound side of the North Railroad Avenue

- Guiderail on north side of North Railroad Avenue (CR 602), north of Lerro Road to be replaced to conform with the latest MASH requirements.

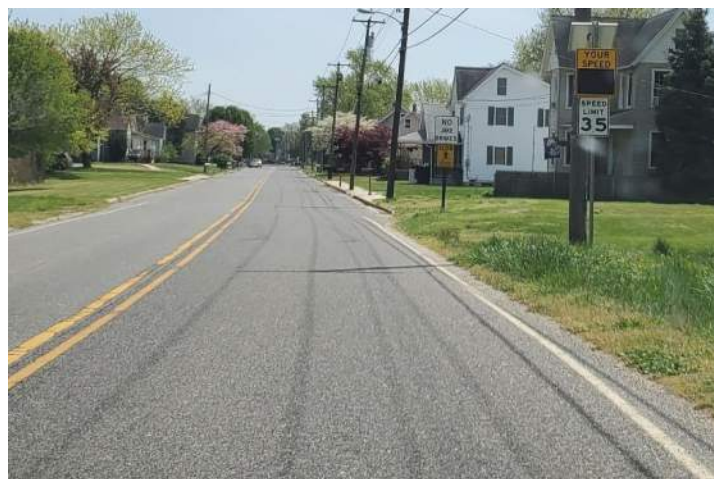
The speed data analysis showed that the 85th percentile speed between Lerro Road and Mill Street is 35 mph, which is comparable with posted speed limit. In addition, the speed data analysis between the railroad tracks and Rt 130 showed that the 85th percentile speed is 43 mph for this section of the North Railroad, which is lower than the posted speed limit. It is worth noting that the radar speed sign is present on the southbound North Railroad Avenue (Photo 31) that contributes to the compatibility of 85th percentile speed and posted speed limit.

Photo 40: Radar speed sign on the southbound of North Railroad Avenue

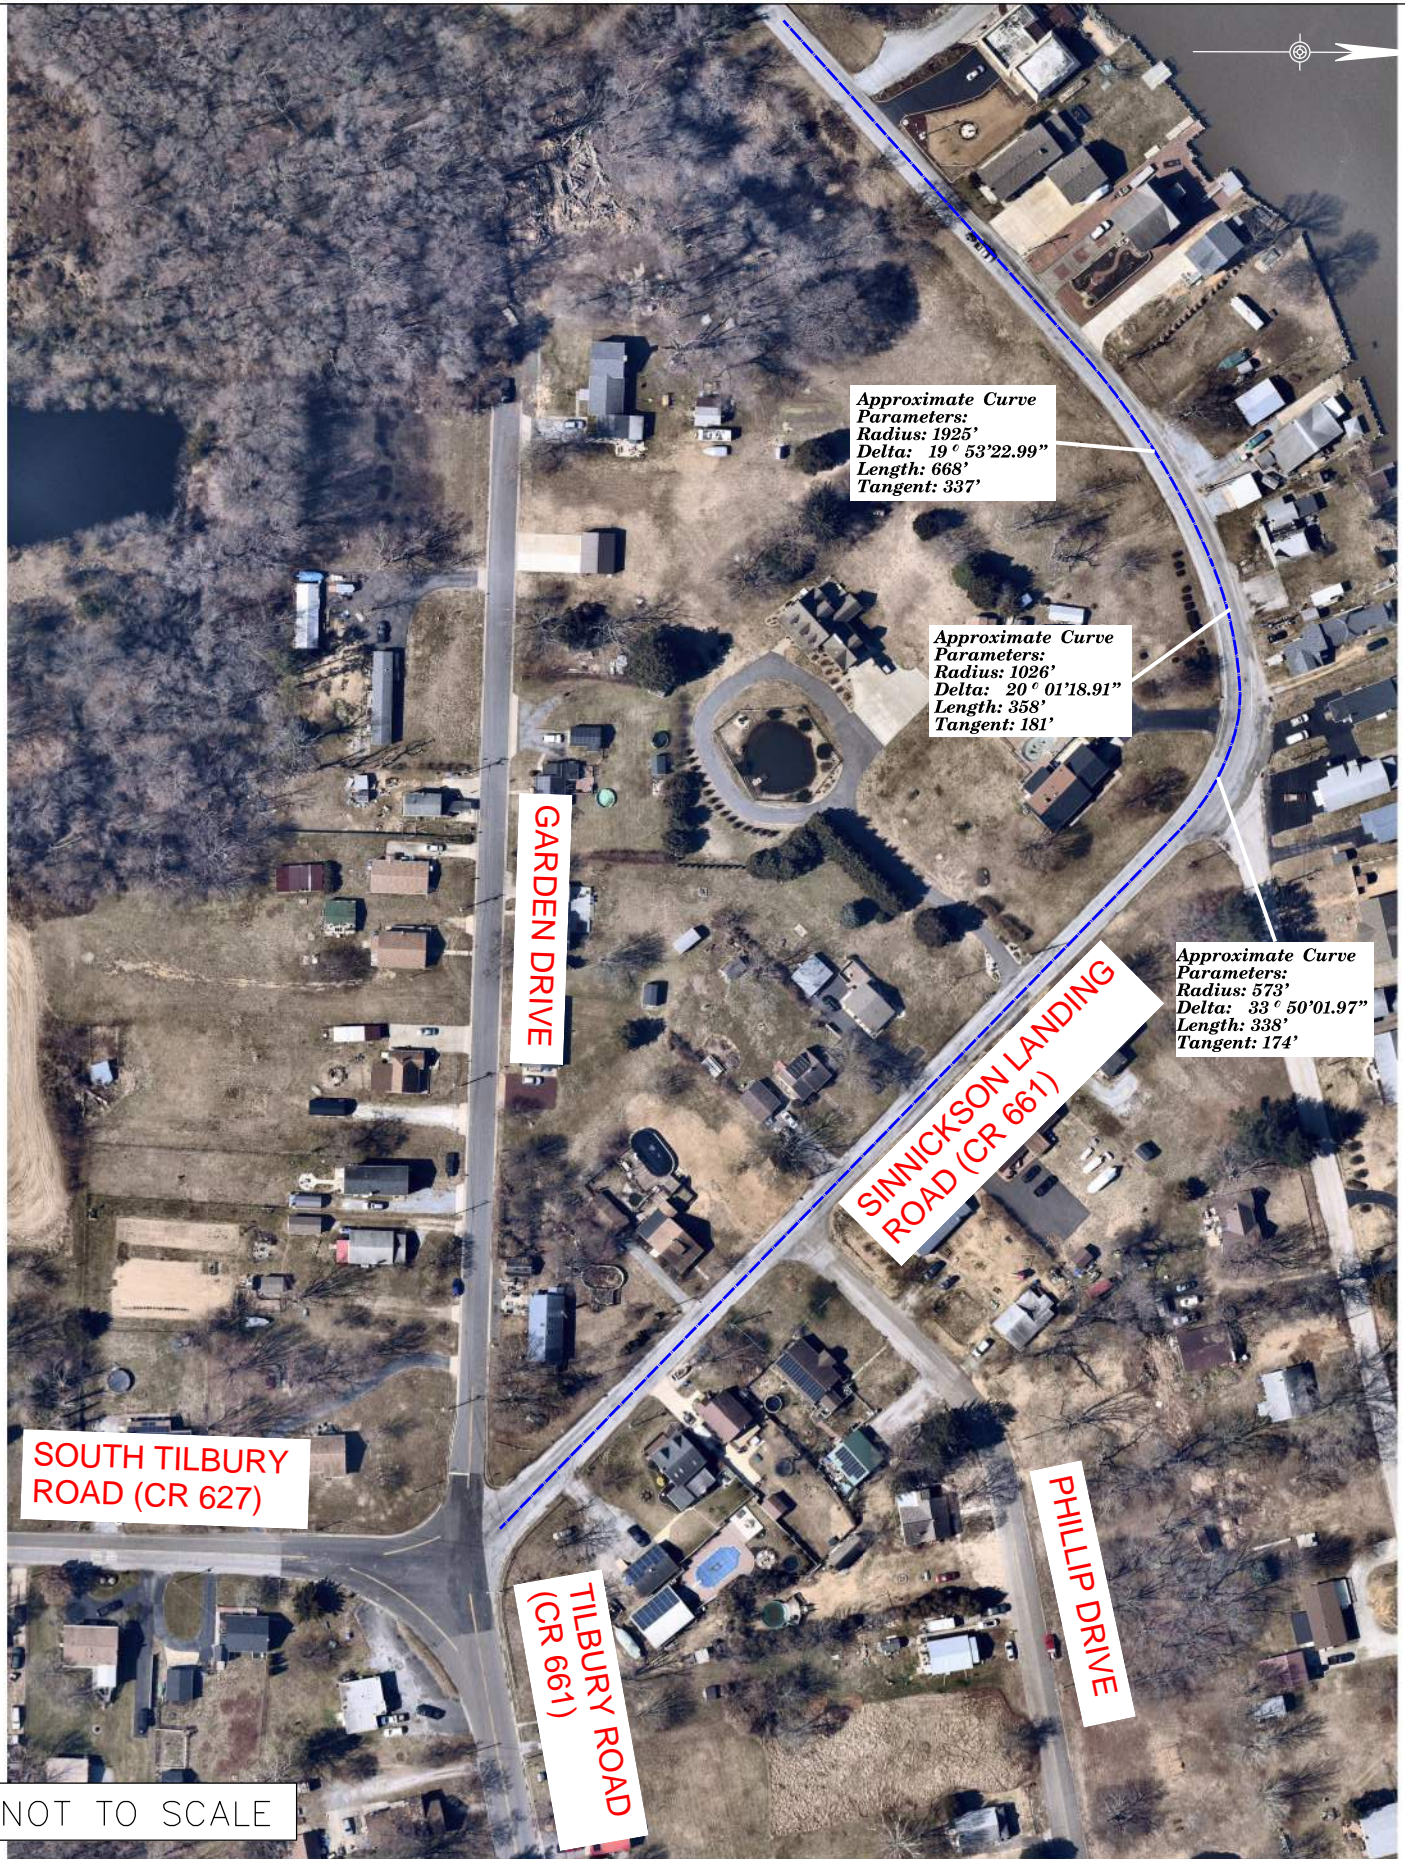
Approximate Curve
Parameters:
Radius: 1925'
Delta: 19° 53' 22.99"
Length: 668'
Tangent: 337'
